# Planning Tools for the Santo Domingo Pueblo: Aiding the Long Term Strategy for Housing Rehabilitation

# Planning Tools for the Santo Domingo Pueblo

*Guidelines for Future Housing Rehabilitation*

An Interactive Qualifying Proposal submitted to the faculty of Worcester Polytechnic Institute in partial fulfillment of the requirements for the Degree of the Bachelor of Science.

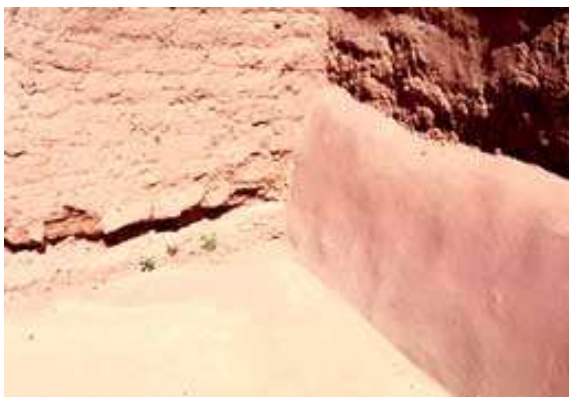
**Figure 7: Evidence of Coving in Adobe Building<sup>46</sup>**

Common sources of deterioration include water, wind, and material incompatibilities. Since traditional adobe structures are made from earth, rain and groundwater can do significant damage. Roofs and walls are easily eroded by rainfall, and when they dry after a storm, they can develop cracks and pitted surfaces. The adobe bricks themselves can also be damaged by repeated soaking and drying, often losing integrity and crumbling. In addition, if the foundation of the building is not properly drained, any standing water that gathers at the base of the structure will cause coving (a hollow space underneath the bottom of a wall). In extreme cases, the adobe will be saturated by water and will start to behave more like a liquid than a solid. Wind erosion is less prevalent than water damage, but it is possible for sand lifted by the wind to furrow the walls, and can be differentiated from water erosion by its visibility on the upper part of the walls and near the corners of the roof. Another common source of damage arises from repair attempts. Some techniques used to maintain and preserve adobe buildings in the past are no longer recommended because of the incompatibility of the materials. For example, some of the weaker materials, such as the mud mortar, were replaced by stronger ones, such as cement mortar. This may seem like an improvement at first, but the adobe ends up falling apart under the pressure caused by the different rates of expansion of the two materials<sup>45</sup>.

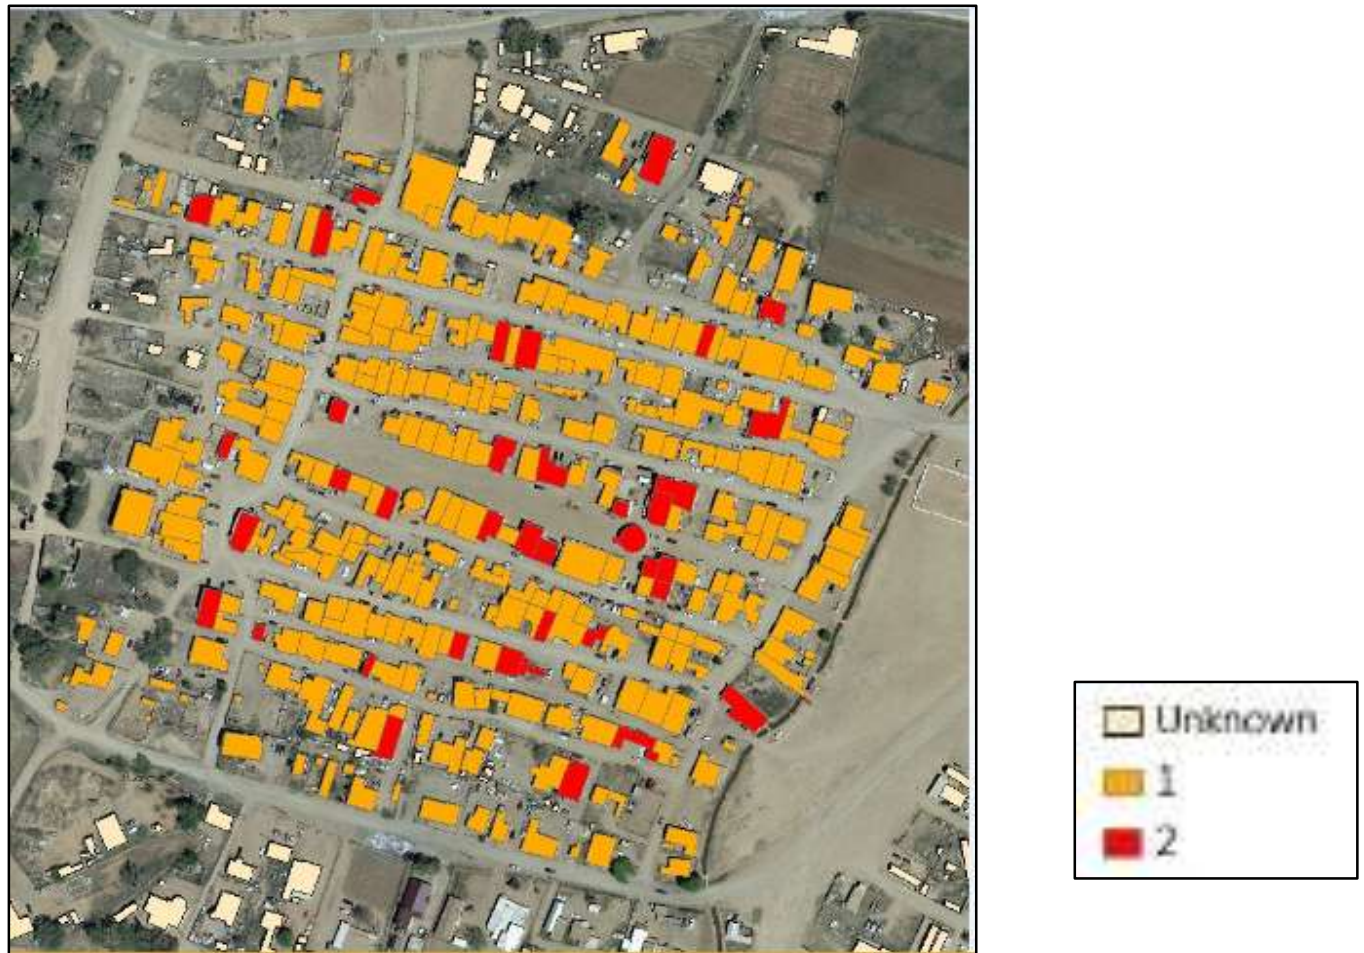
**Figure 23: Number of Stories for Buildings in the Historic Village**

Since buildings with two stories will cost more to rehabilitate, it is important to keep track of how many stories each building has. Two story buildings also pose a bigger threat as they deteriorate, causing more damage if they collapse.

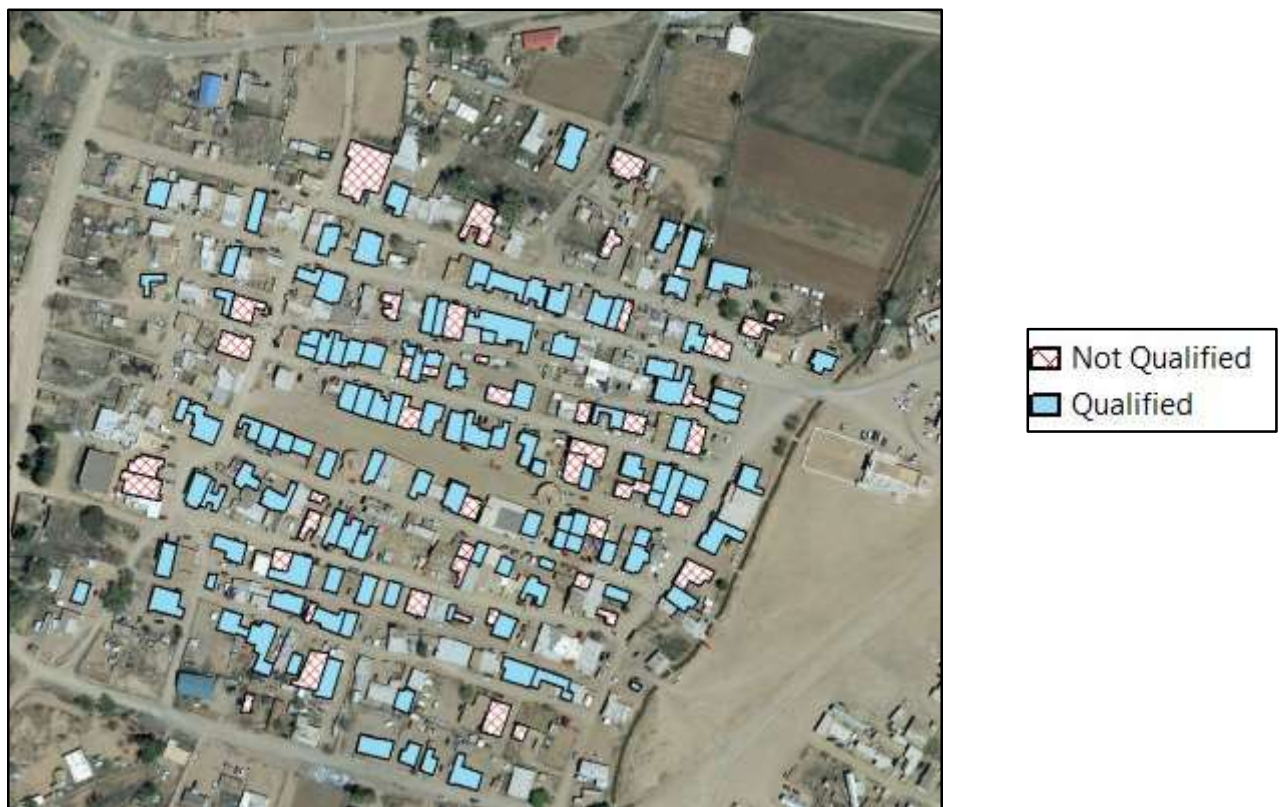
**Figure 32: Qualified Homes**

In order to select which houses were to be rehabilitated first, we used the unweighted points system we had created. The units highlighted in red denote failure to qualify for rehabilitation due to being in good condition or uninhabited. The map shown in Figure 32 geographically displays which buildings were assessed for the proposed structural and building use criteria based on the qualifications for rehabilitation, which entailed being inhabited and assessed for an overall condition less than good.

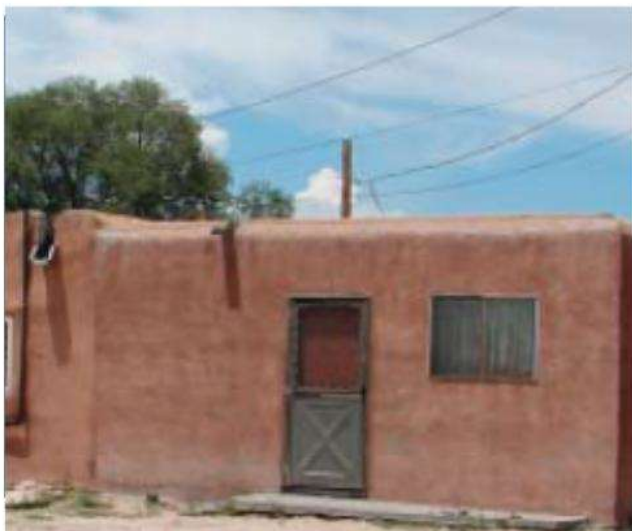
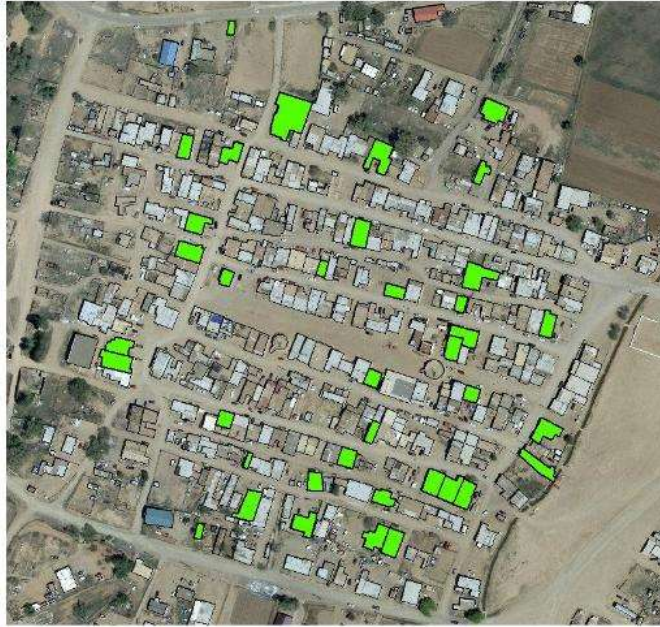
51 Units in Good Overall Condition

## Good Condition

- No significant display of wall deterioration
- Building components (window and door) in good condition

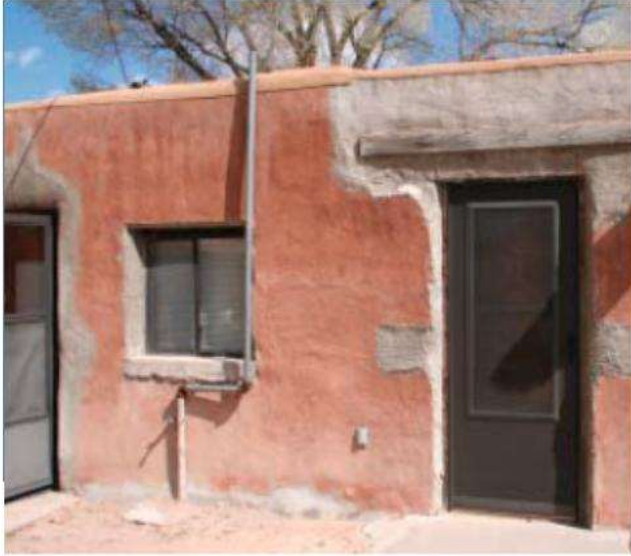
115 Units in Fair Overall Condition

## Fair Condition

- Spalling looks present toward top of building
- Wall has minor visible deterioration

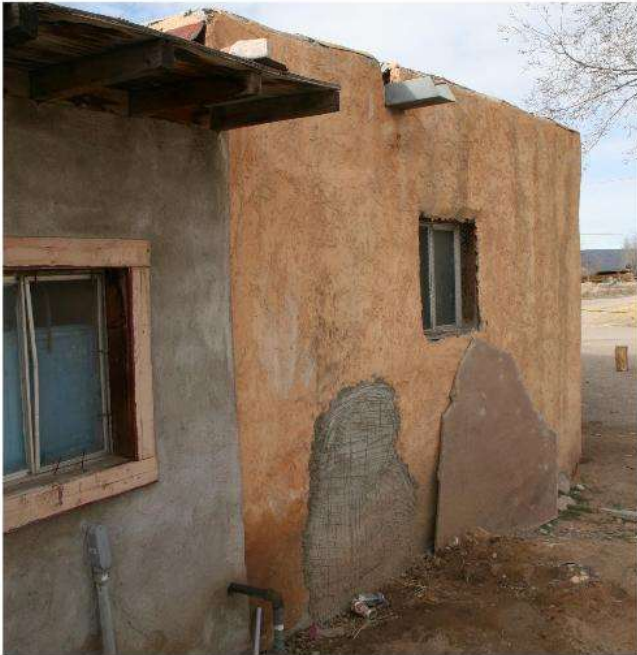
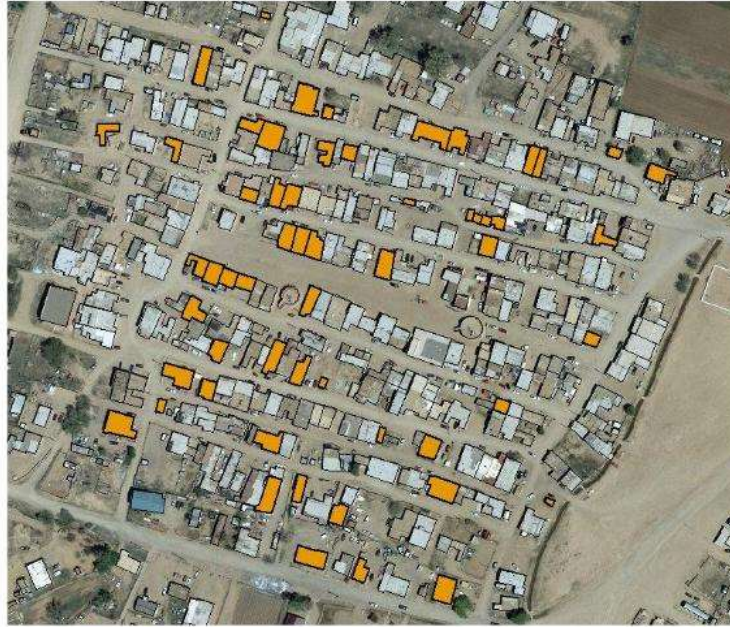
70 Units in Poor Overall Condition

## Poor Condition

- Different surface coatings
- Windows in poor condition
- Roof deterioration is visible

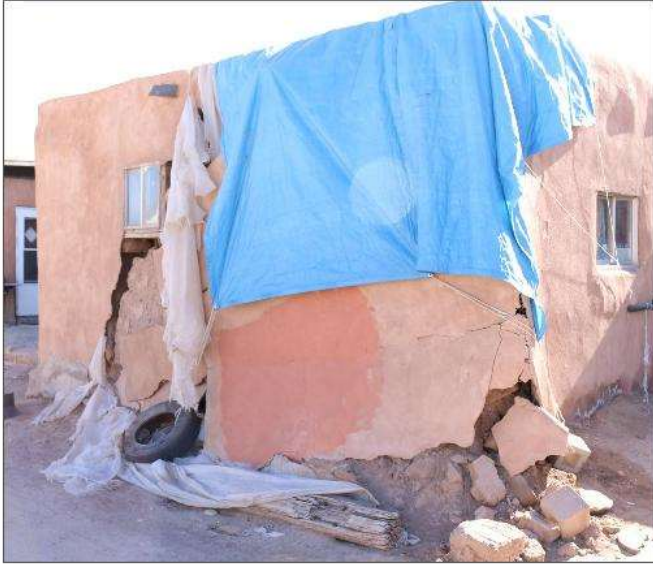
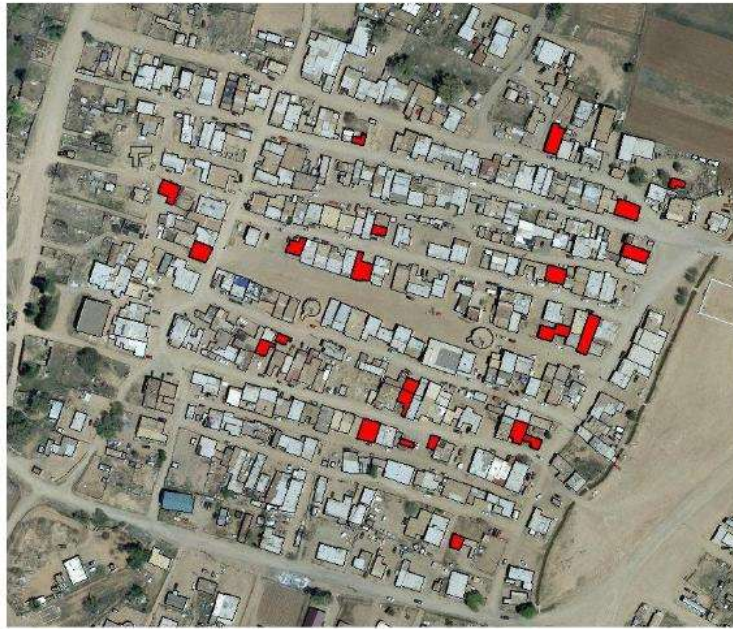
36 Units in Severe Overall Condition

## Severe Condition

- Total Collapse of wall

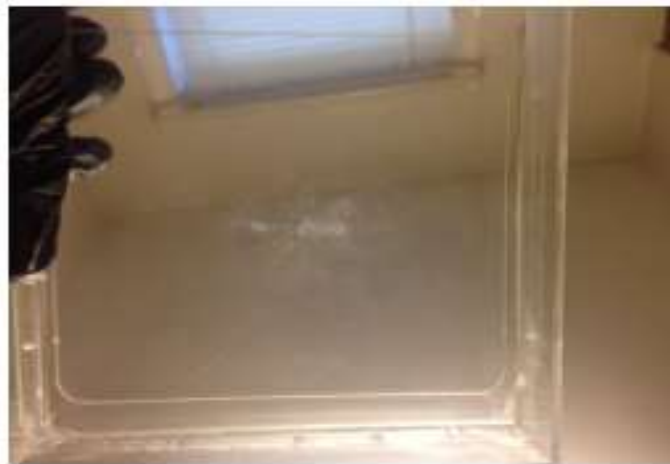
When printing the buildings for the Historic Village, the success rate was incredibly low, around 30%. After studying the failed prints, four main causes were found. The first cause of failure was that digital model was put over a damaged part of the tray in Preform. The image below shows a tray with a damaged section.

The cloudy part in the middle of the tray is the damaged section. The trays cloud over time from repeated printing in the same area. A failed print also causes significantly more damage to the tray. When a print fails, resin sticks to the bottom of the tray. That already hardened resin is hit repeatedly with the laser, damaging the tray more than it usually would be damaged. It is important to check the tray after each print to see if any new damaged areas have appeared. Printing over a clouded area greatly reduces the probability of getting a successful print. Damage to the tray can also occur from removing excess print residue from the tray. This residue sticks to the bottom of the tray and must be carefully removed. If this is done incorrectly, the pieces of the bottom of the tray, which is made of silicon, can be torn off the tray. When this happens, that portion of the tray can no longer be used again. Proper removal of residue will be discussed in the section describing steps for after a print has finished.

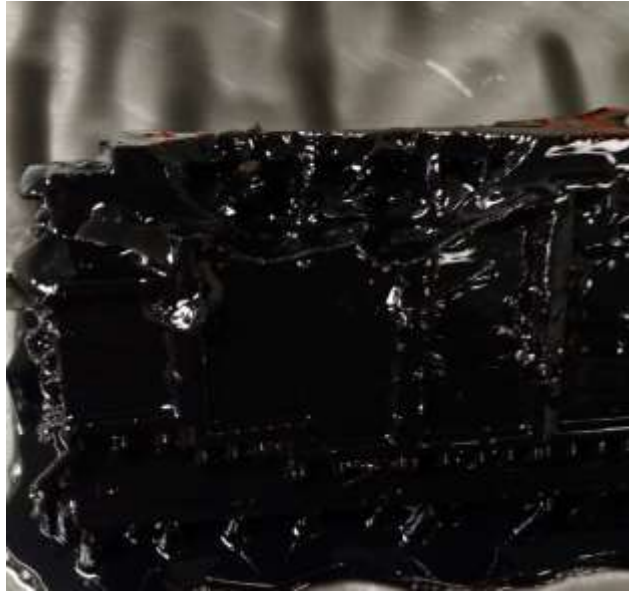
The last main cause of failure was the orientation of the models. After many print failures, it was determined that the building parts of the models were causing air pockets to form around them. Because the buildings stick out from the rest of the model, when the printer moved up a layer, the fluid would sometimes not fill in around the buildings. This caused print failures because with no resin to harden over the model, that part of the layer would be incomplete, causing every layer after it to fail as well. The picture below is a print that failed for this reason:

The print appears to have failed at one small point, which caused the failure to spread over a larger area as the more layers were added.
